ATTORNEY-CLIENT PRIVILEGE/FOIA-EXEMPT  
United States Environmental Protection Agency  
INVESTIGATIVE ACTIVITY REPORT

Case Name:  
AK STEEL

Subject of Report:  
INTERVIEW OF [Non-responsive] AT HIS RESIDENCE OF [Non-responsive]  
[Non-responsive]

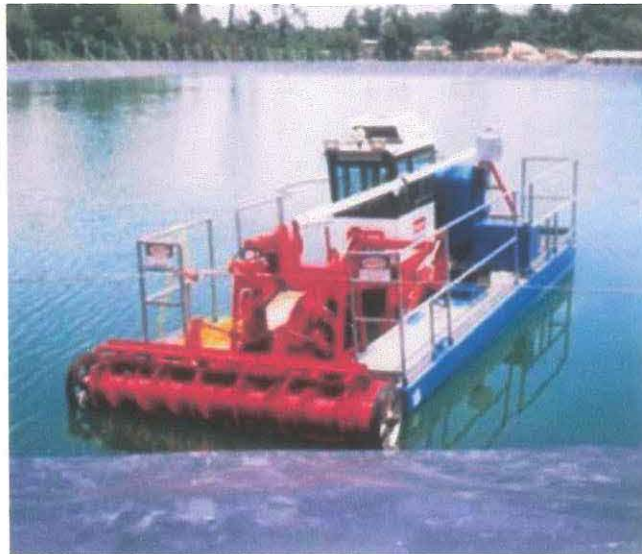
Figure 2. Photograph of Mudcat SP-810 and specifications from [www.Ellicott.com](http://www.Ellicott.com).

MUD CAT™ AUGER MODEL SP-810	
Length (O.A.)	28 ft 6 in (8.68 m)
Width (O.A.)	8 ft 0 in (2.44 m)
Height (O.A.)	9 ft (2.85 m)
Weight	15,500 lbs (7030 kg) dry
Draft	25 in (0.64 m)
Fuel Capacity	180 gallons (680 liters)
Cut	8 ft (2.44 m) wide x 18 in (.457 m) maximum depth
Operating Depth	10.5 ft (3.2 m) Maximum
Suction Diameter	6 in (152 mm) (8 in [203 mm] available as option)
Discharge Diameter	6 in (152 mm)
Nominal Pump Performance	1000 GPM (3785 liters/min) against 100 ft (30.5 m) Head (water) at 1600 RPM

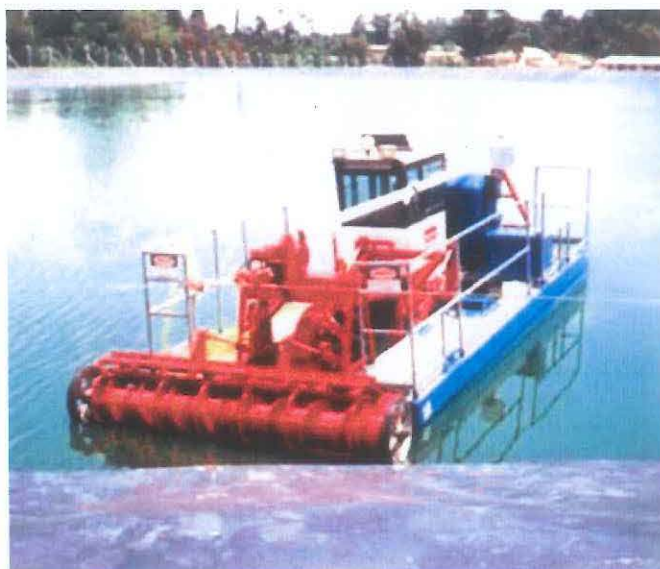
Figure 2. Photograph of Mudcat SP-810 and specifications from [www.Ellicott.com](http://www.Ellicott.com).

MUD CAT™ AUGER MODEL SP-810	
Length (O.A.)	28 ft 6 in (8.68 m)
Width (O.A.)	8 ft 0 in (2.44 m)
Height (O.A.)	9 ft (2.85 m)
Weight	15,500 lbs (7030 kg) dry
Draft	25 in (0.64 m)
Fuel Capacity	180 gallons (680 liters)
Cut	8 ft (2.44 m) wide x 18 in (.457 m) maximum depth
Operating Depth	10.5 ft (3.2 m) Maximum
Suction Diameter	6 in (152 mm) (8 in [203 mm] available as option)
Discharge Diameter	6 in (152 mm)
Nominal Pump Performance	1000 GPM (3785 liters/min) against 100 ft (30.5 m) Head (water) at 1600 RPM

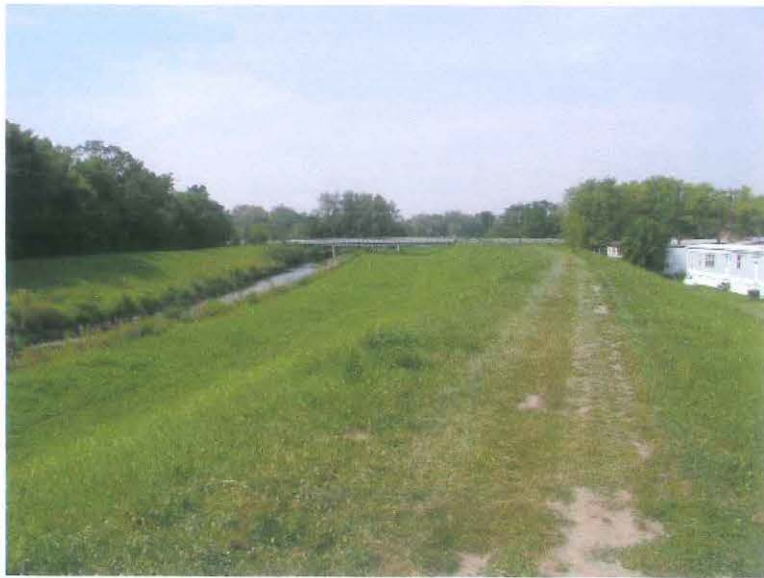
Mowed berm separates  
Excello Trailer Park from  
Dick's Creek near Main  
Street overpass

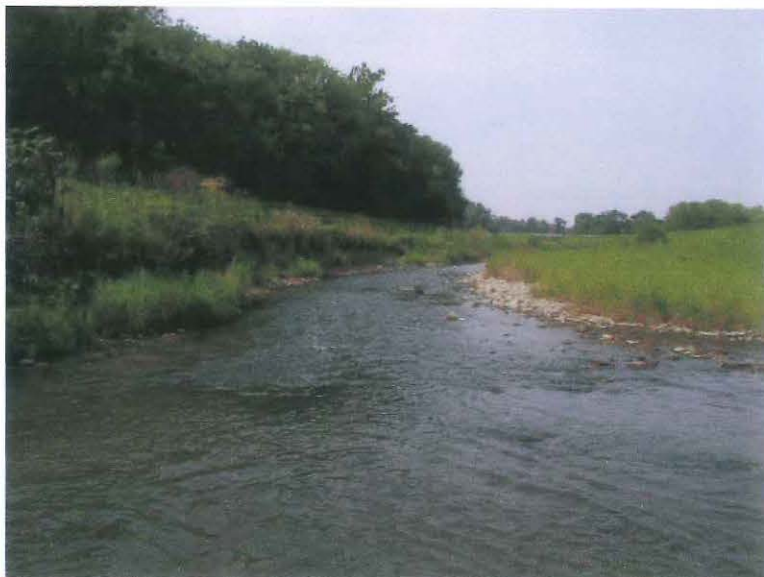
No riparian cover, low  
complexity of in stream  
habitat

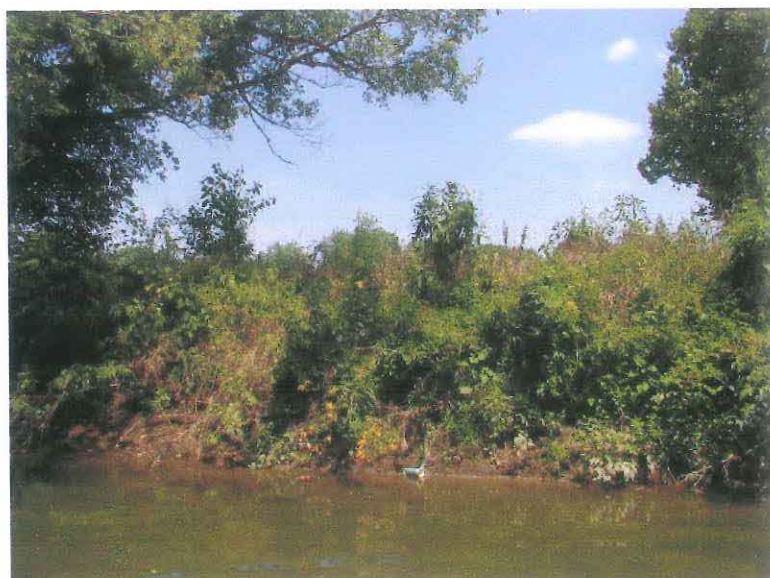
QHEI Location A

(Note: pipe appears to be  
drain tile from farm field)
